WWAC2016

4th IWA International Symposium
on Water and Wastewater Technologies
in Ancient Civilizations

Preliminary Results of the Archaeological Surveys Conducted at the Álamo Roman Dam (Alcoutim, Portugal) During the Years of 2006 and 2007 ¹

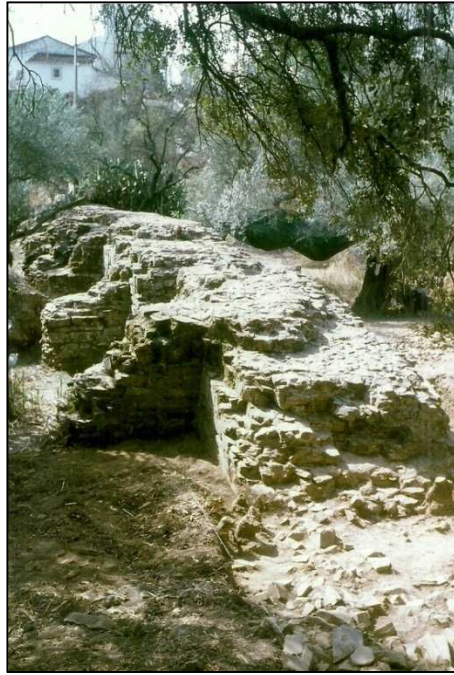
The dam consists of a wall approx. 40 m long (more 10 m identified by the survey of 2006) and a thickness of 2.80 m, reinforced by 7 visible buttresses of 1.5 m length on the downstream side (Fig. 1). Spacing between buttresses is approximately 3 m. The entire construction, including the buttresses, was achieved using greywacke blocks with mortar, laid in horizontal layers (*opus incertum*). Near the north end it contains also a short section with a buttress that separated and collapsed probably due to lack of foundation support.

Figure 1. Dam of Álamo. General view. Note the constructive technique, by the successive layers of cemented blocks, that constitutes the nucleus of the structure. Both walls and buttresses are covered by horizontal layers of blocks of greywacke (*opus incertum*). Photo J. L. Cardoso.

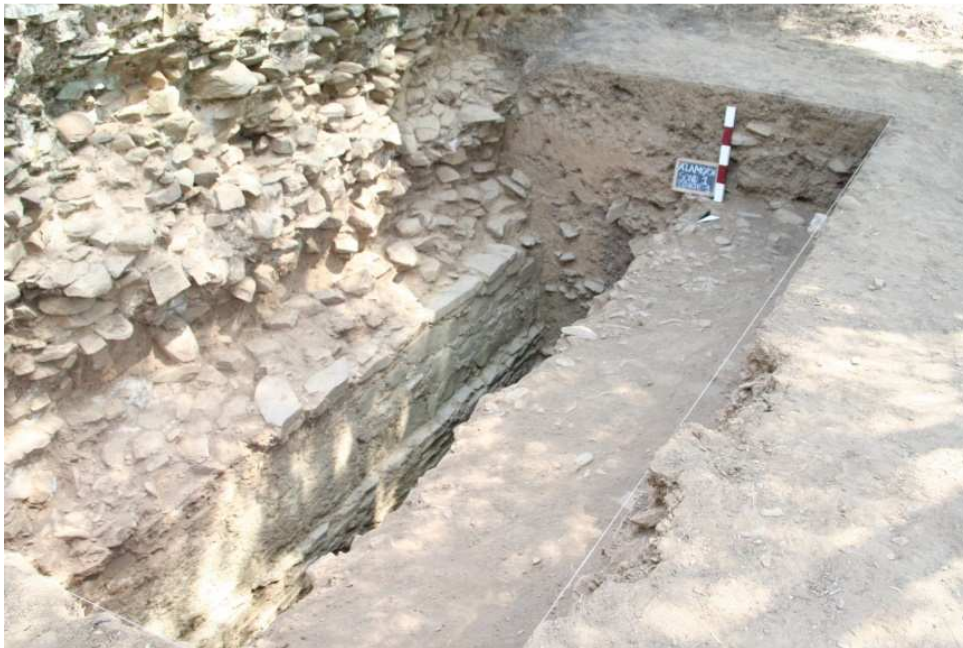
One evidence that is observed only in the upstream side of the dam is the damaging of the *opus incertum* revetment of the nucleus of the structure provoking by the severe erosive action of the waves generated in the reservoir combined with the variation of the correspondent water level along the year (Fig. 4).

Figure 4. Partial view of Survey 1 (2006), showing the contrast between the conservation of the upper part of the upstream wall and the lower part, interred in the sediments accumulated at the bottom of the reservoir. Photo J. L. Cardoso.

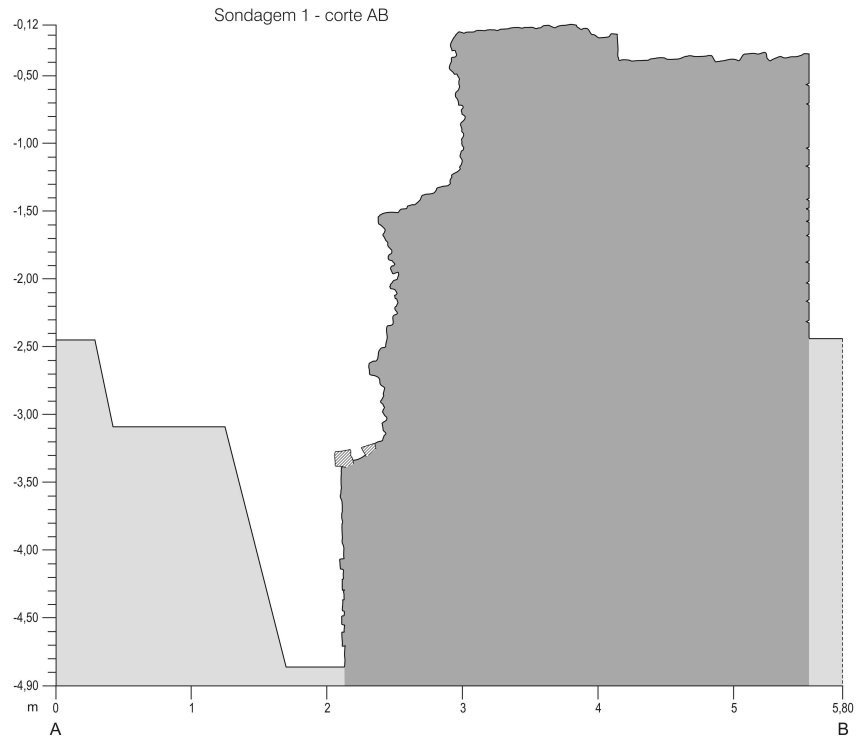
This survey did showed the good preservation of the dam upstream wall protected by the sediments, contrasting to the major erosion evident at surface height, which showed the antiquity of silting, as the two cross sections clearly shows (Fig 6 and Fig. 7). Although the dam wall revealed a homogeneous make-up of well-adjusted greywacke blocks (*opus incertum*), it did show a small longitudinal structural ledge (Fig. 8).

Figure 6. Dam of Álamo. Cross section AB of Survey 1 (2006) (see Fig. 5) dressed by B. Ferreira under the supervision of J. L. Cardoso.

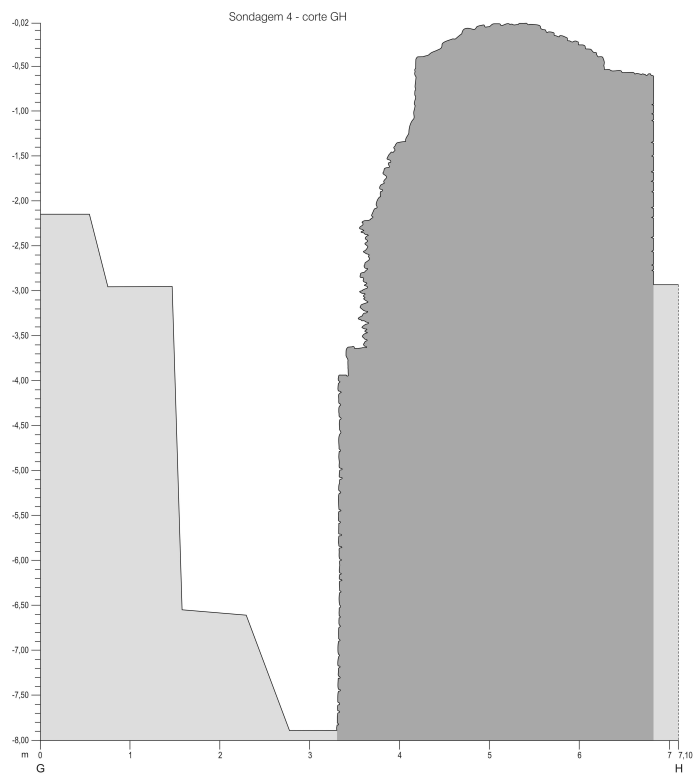
Figure 7. Dam of Álamo. Cross section GH of Survey 4 (2007) (see Fig. 5) dressed by B. Ferreira under the supervision of J. L. Cardoso.

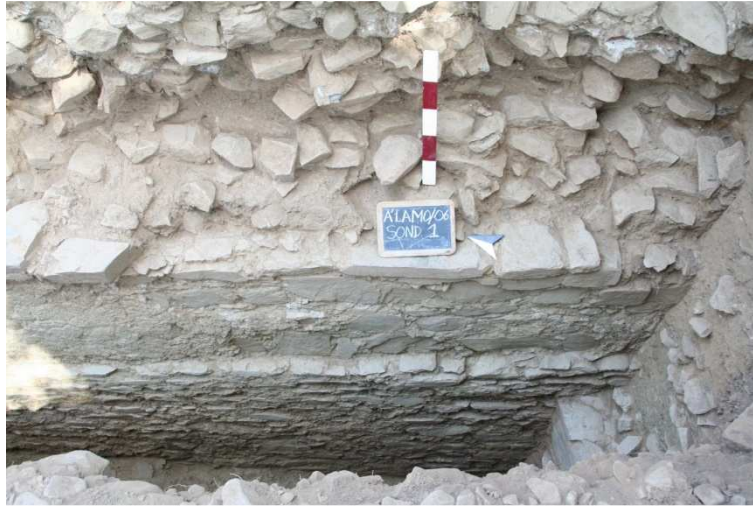
Figure 8. Dam of Álamo. Partial view of the upstream wall, observed in Survey 1 (2006), with a small longitudinal step. Photo A. Gradim.

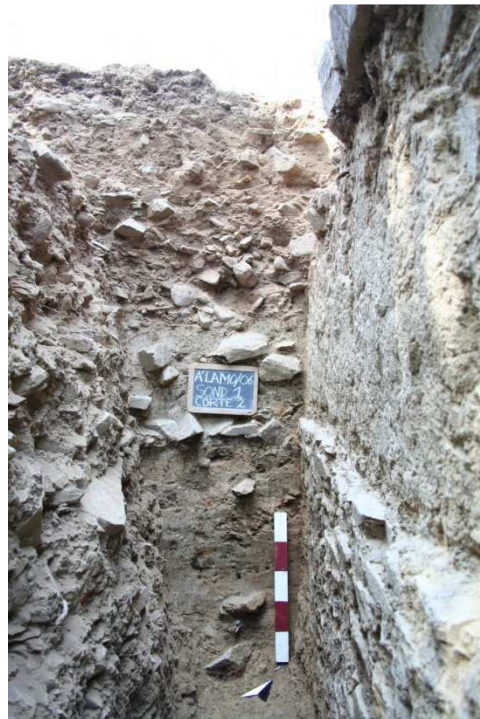
The Fig. 9 corresponds to a cut made on the sediments accumulated against the upstream wall, shows very well the importance of them, with 2.30 m in height in this dam sector, also registered in the stratigraphic cut (Fig. 10). So the bottom part of the sedimentary accumulation is mostly filled by fine sediment laid down at the bottom of the old reservoir, followed by layers with increasingly abundant rough greywacke blocks, partially as a result of the erosive action of the waves against the upper stream wall of the dam, combined with the variation of the water level in the reservoir. This layer of blocks seems to set the time when the structure was abandoned; but along all the sedimentary sequence we can observe large blocks, detached from the wall of the dam, due to the above mentioned actions, during its utile life. Of course, it must be also in mind the contribution of blocks from upstream, carried by the flash flooding of the river, which is known to flood at certain periods of the year, according to its torrential regime, typical Mediterranean.

Figure 9. Dam of Álamo. Stratigraphic cross section 2 of Survey 1 (2006) (see Fig. 5). Note the existence of a mortar covering partially the wall of the dam, protected by sediments. Photo A. Gradim.

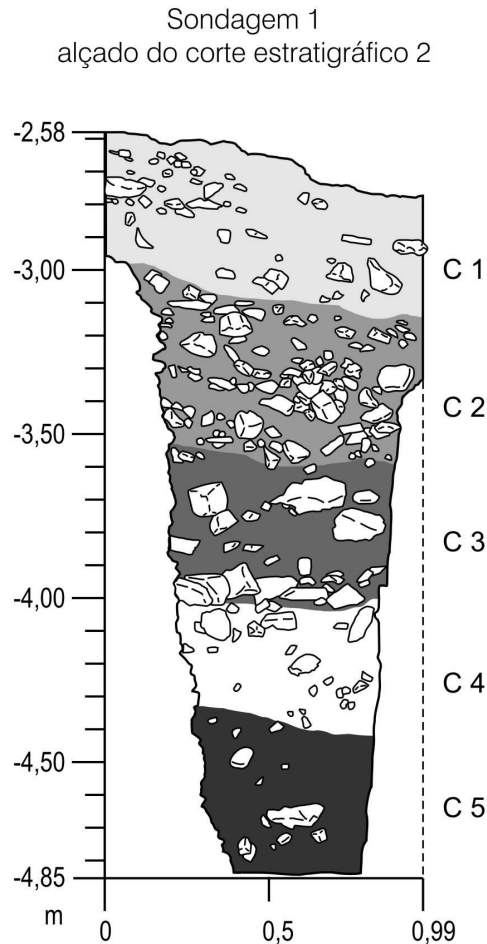
Figure 10. Dam of Álamo. Stratigraphic cross section 2 of Survey 1 (2006) (see Fig. 5). Legend: Base (C5)– the oldest deposit corresponds to essentially fine sediments at the bottom; Middle (C4/C3) – the large amount of blocks of greywacke of considerable dimensions, as well as its horizontal disposition, indicate that they would have fallen from the upstream wall of the structure, corresponding to its covering at the top; Top (C1/C2) – Evidence of the quick silting of the old reservoir through the effect of torrential water discharges of Barranco da Foupana, as indicates the existence of schist fragments and greywacke arbitrarily oriented in the level. The C1 corresponds to the modern soil. Dressed by B. Ferreira under the supervision of J. L. Cardoso.

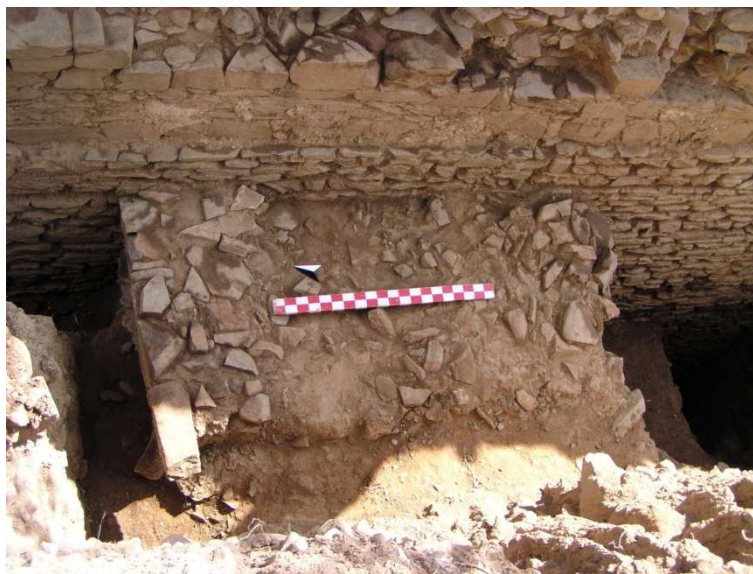
At the southern survey limit, noticed a perpendicular alignment of blocks related to a probable platform built in the central part of the dam. It's possible that this structure, without any structural function due to its position in the structure, eventually related to a direct access to the water. The epoch of their construction is relatively recent in the general sequence of the use of the dam, since it is founded in sediments accumulated at the bottom of the reservoir (Fig. 11).

Figure 11. Dam of Álamo. View of the platform observed in the middle of the upstream wall. Photo J. L. Cardoso.

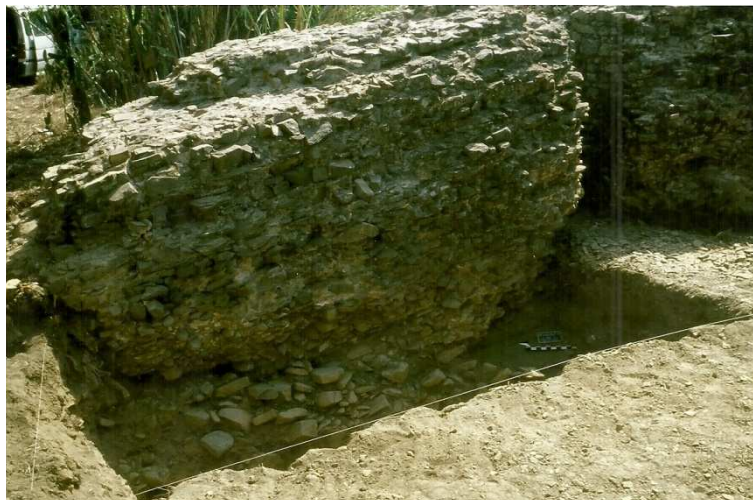
Survey 2 – this survey was implanted in a section of the dam that collapsed, in order to find out the causes of this occurrence. This happened most probably due to excavation under the foundation due to the erosive action of the water line that currently passes through the fissure of the wall (Fig. 12).

Figure 12. Dam of Álamo. Collapsed section of the dam. Photo J. L. Cardoso.

The causes of the collapsing of a section of the dam located at the north end, were investigated by conducting the Survey 2. However, it has not been possible to extend this up to the geological basement, having come across deep blocks resulting from the collapse of the wall, which it was necessary to preserve. Anyway, the observation of this sector, along the fissure produced in the structure, leads to the conclusion that the most likely cause of the collapse was the excavation under the foundation structure due to erosion of the crossing of the waters of the watercourse which today still takes advantage of this fissure to cross through this artificial barrier.

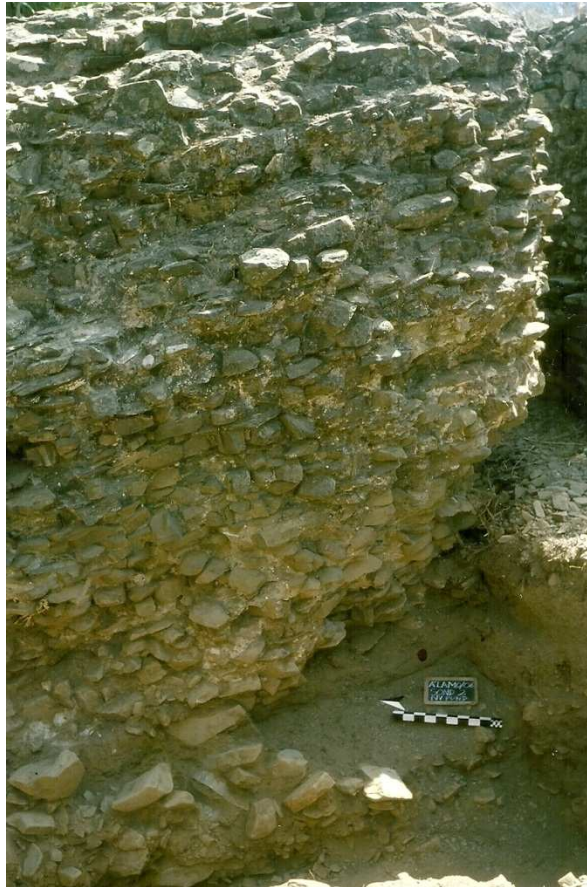
Unfortunately it wasn't possible confirm the cause of the dam wall collapsed, since near the upstream wall the considerable accumulation of blocks as a result of erosion (Fig.14), also represented in the plan, prevented the direct observation of the state of the structure's foundation. We can provisionally conclude, based on the observation of a small section in the excavated area close to the fissure in the wall, where currently the water line passes through, that the cause of the collapse was due to the water line undermining the foundation structure.

Figure 14. Dam of Álamo. Detail of Survey 2 (2006). Note the existence of fine sediments under the basement of the collapsed section of the wall by the waters of the Ribeira da Foupana that currently crosses the structure through the existent fissure. Photo J. L. Cardoso.

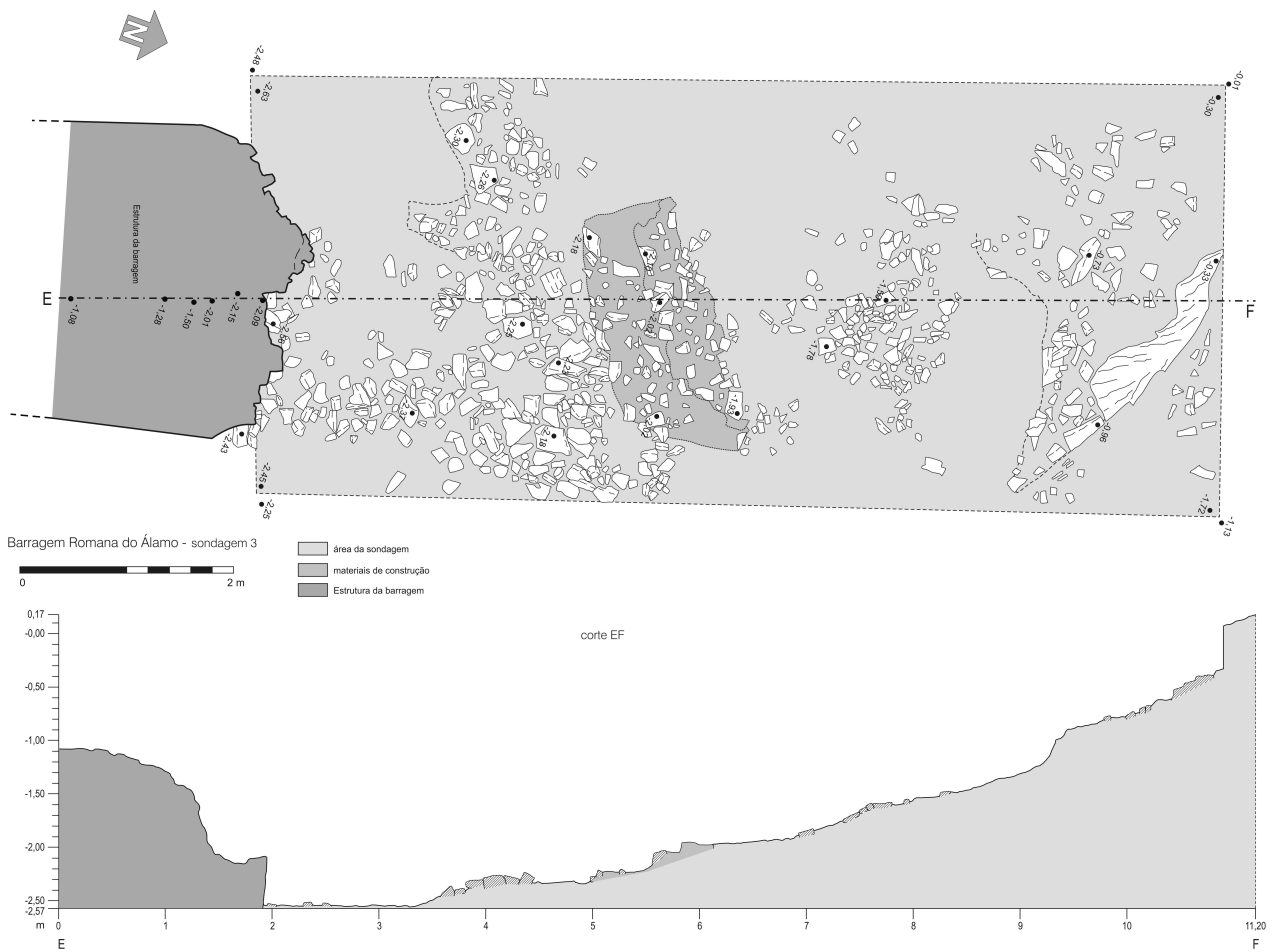
Survey 3 – this survey was applied to the alignment of the dam with its meeting point at the slope of the left ridge (Fig. 15). This location was aimed at identifying the rest of the structure not visible at the original surface of the ground but signalled by Estacio da Veiga in 1877 (see Fig. 2). It was essentially an excavation in extension of an elongated rectangle, 9 meters long by 4 meters wide. All the aims were accomplished as it allowed us to observe a specific area covered with a sandy mortar embedding some greywacke blocks of the same type as the ones used at the nucleus of the dam (Fig. 16). According to this it can be concluded that this sector, in grey at Fig.15, it's what's subsist of the left foundation of the dam, that allows one to determine that its length would have been about 10 meters more than the current one, totalizing 50 meters long (Fig. 3).

Figure 15. Dam of Álamo. Plan and cross section Survey 3 (2006). In the middle of the excavated area, is conserved blocks cemented by sandy-chalky mortar that corresponds to the basement of the structure. Dressed by B. Ferreira under the supervision of J. L. Cardoso.

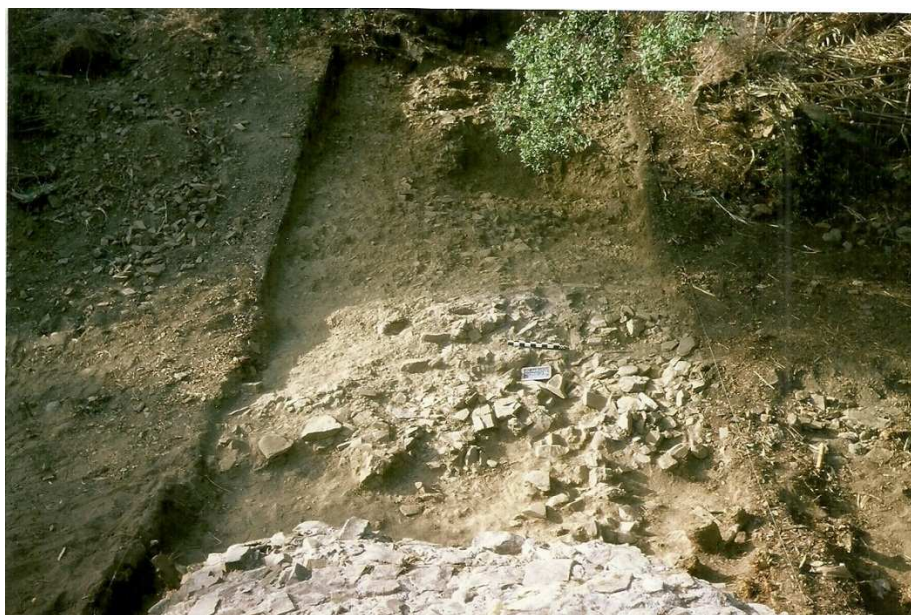
Figure 16. Dam of Álamo. Survey 2 (2006), evidencing the regularization of the geologic basement over which the dam was built. Note the remains of the foundation layer of the structure corresponding to blocks of greywacke cemented by a sandy-chalky mortar. Photo J. L. Cardoso

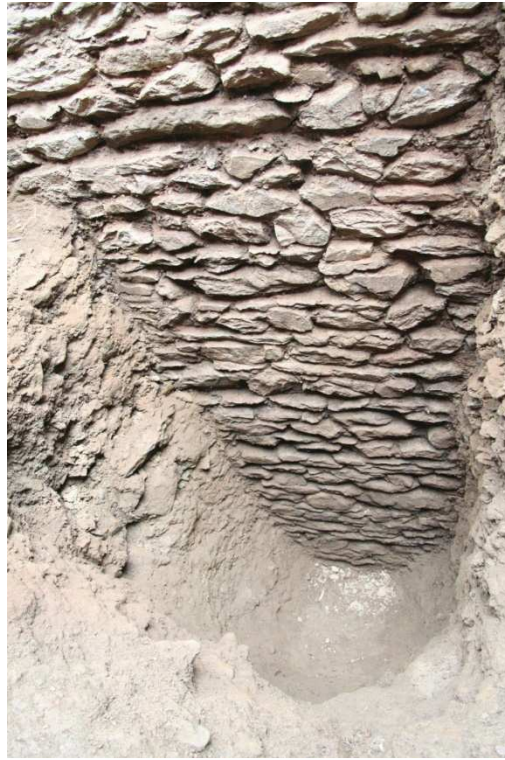
Survey 4 – this survey was performed in 2007, with the main propose to determine the maximum height of the dam, since it corresponds to the central area of the river valley, where the sediment thickness reaches its maximum. It was executed close to the surface of the upstream wall and in the continuity of survey 1, reaching a length of approximately 7.0 m and a width of 3.20 m (Fig. 17).

Figure 17. Dam of Álamo. Detail of the upstream wall built with isometric blocks of greywacke (*opus incertum*), observed at Survey 4 (2007). Note at the bottom the geological substratum. Photo A. Gradim.

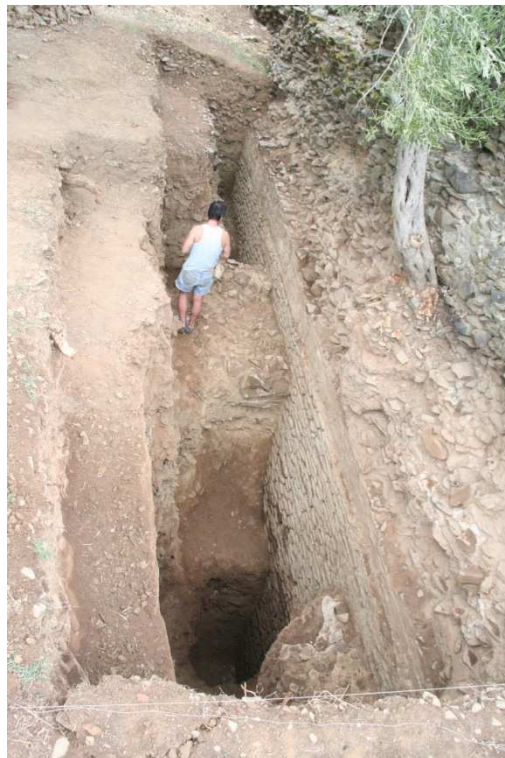
Due to the possibility of collapse of the cut, excavated without planking, which reached the maximum depth below the current ground level of 5.75 m, the geological substrate was attained only in a limited area, covered by fine clay sediment with greenish colour that was the first to accumulate at the bottom of the old reservoir (Fig. 18).

Figure 18. Dam of Álamo. Partial view of the excavation field season of 2007 (Survey 4). Photo A. Gradim.

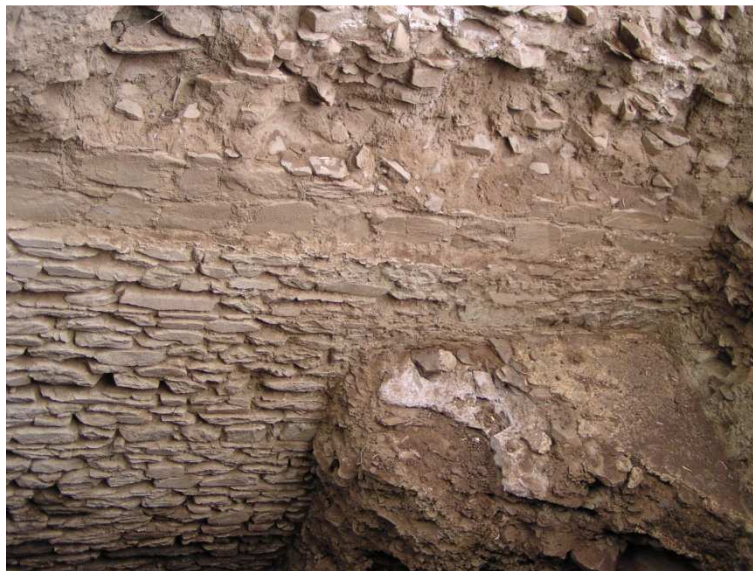
At the South end of this survey, it was identified a regular flat surface, consisting of thin whitish mortar, involving small blocks of greywacke, leaning the upstream wall of the dam, superimposed by another more yellowish layer (Fig. 19). It's hard to know the exactly purpose of these two floors, made in different times and over natural surface deposits meanwhile accumulated at the bottom of the old reservoir, what proves that, just like the above mentioned platform, are related to secondary use of water storage in the old reservoir.

Figure 19. Dam of Álamo. Partial view of two layers of mortar, in the middle of the ancient reservoir near the upstream wall, made over the deposits accumulated at the bottom of the reservoir. See Fig. 5. Photo J. L. Cardoso.
