WWAC2016

4th IWA International Symposium
on Water and Wastewater Technologies
in Ancient Civilizations

Preliminary Results of the Archaeological Surveys Conducted at the Álamo Roman Dam (Alcoutim, Portugal) During the Years of 2006 and 2007 ¹

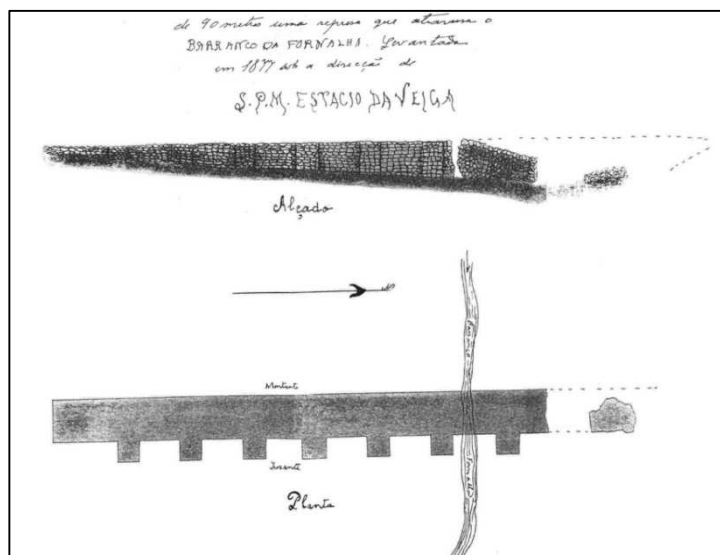
In 1877, the Algarve-born archaeologist S. P. M. Estácio da Veiga, made the first graphic records of the dam, with the assistance of A. de Serpa (Fig. 2) and he also registered a roman *villa*, with corresponding acropolis located downstream. During the excavations made at the site he recovered a few objects. The most important amongst them was a marble statue representing the young god *Apollo*. It is presumed that there was an association between this roman structures and the dam, the water collection of which was presumably for irrigation and possibly for domestic use (Quintela, Cardoso & Mascarenhas, 1986; Cardoso, 1990).

Figure 2. Dam of Álamo. Plan dressed by S. P. M. Estácio da Veiga in 1877 (files of National Archaeological Museum, Lisbon, cf. Santos, 1972, modified).

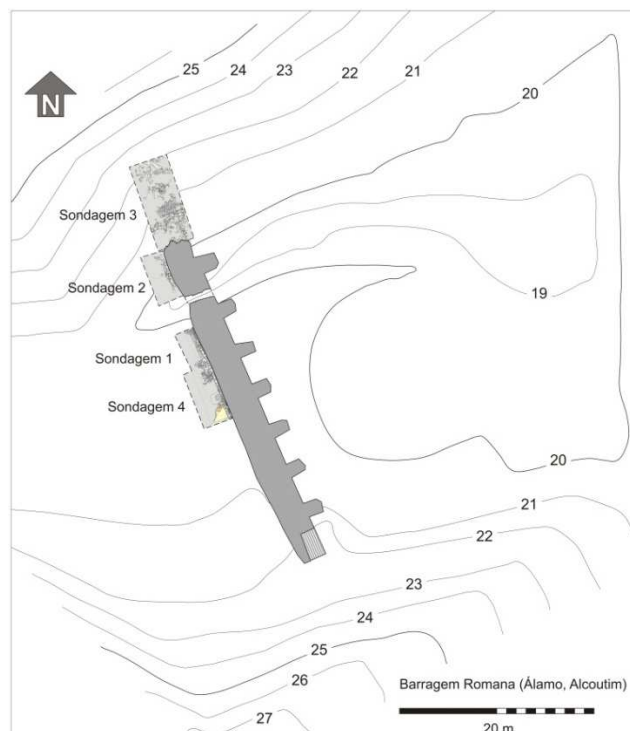
In 2007, a last survey was open, adjacent to the survey 1, in order to attain the basement of the structure in the deepest sector of the ancient reservoir, in the central area of the valley (Fig. 3).

Figure 3. Dam of Álamo. General plan of the dam and location of the surveys.

Survey 3 – this survey was applied to the alignment of the dam with its meeting point at the slope of the left ridge (Fig. 15). This location was aimed at identifying the rest of the structure not visible at the original surface of the ground but signalled by Estacio da Veiga in 1877 (see Fig. 2). It was essentially an excavation in extension of an elongated rectangle, 9 meters long by 4 meters wide. All the aims were accomplished as it allowed us to observe a specific area covered with a sandy mortar embedding some greywacke blocks of the same type as the ones used at the nucleus of the dam (Fig. 16). According to this it can be concluded that this sector, in grey at Fig.15, it's what's subsist of the left foundation of the dam, that allows one to determine that its length would have been about 10 meters more than the current one, totalizing 50 meters long (Fig. 3).
